Pentium® II Xeon™ Processor Specification Update

Release Date: June 1998

Order Number: 243776-001

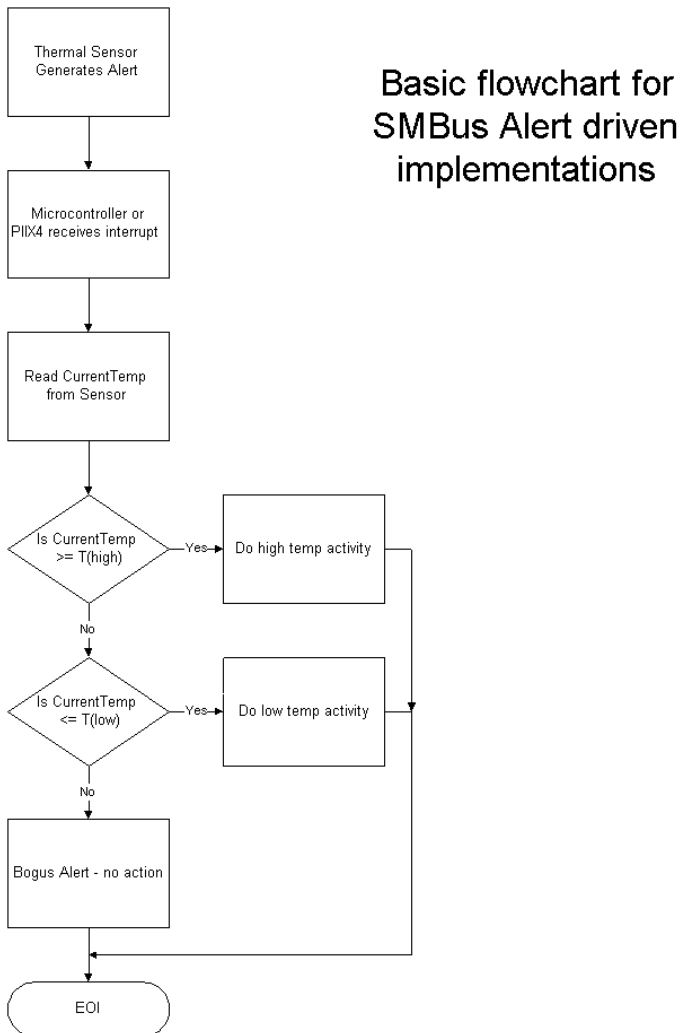
Figure 2. Workaround Flowchart: SMBALERT#-Driven System

30. *Thermal Sensor May Assert SMBALERT# Incorrectly*

PROBLEM: The Pentium II Xeon processor has a thermal sensor that monitors the processor core's temperature. The thermal sensor asserts SMBALERT# if the processor temperature exceeds the temperature limits set in the Alarm Threshold Registers (T_{HIGH} , T_{LOW}). It also sets the corresponding Status Register bits to identify the cause of the interrupt. Figure 1 gives one example of the how the SMBALERT# signal could be used in a system.

Under the conditions described below, the thermal sensor incorrectly generates the SMBALERT# interrupt. **All** of the following conditions must be met to trigger a false interrupt:

Basic flowchart for system interrupt driven implementations
